GREAT LAKES INDIAN FISH & WILDLIFE COMMISSION

Date: August 13, 2001

RE: Report on the status of the Flambeau Mine

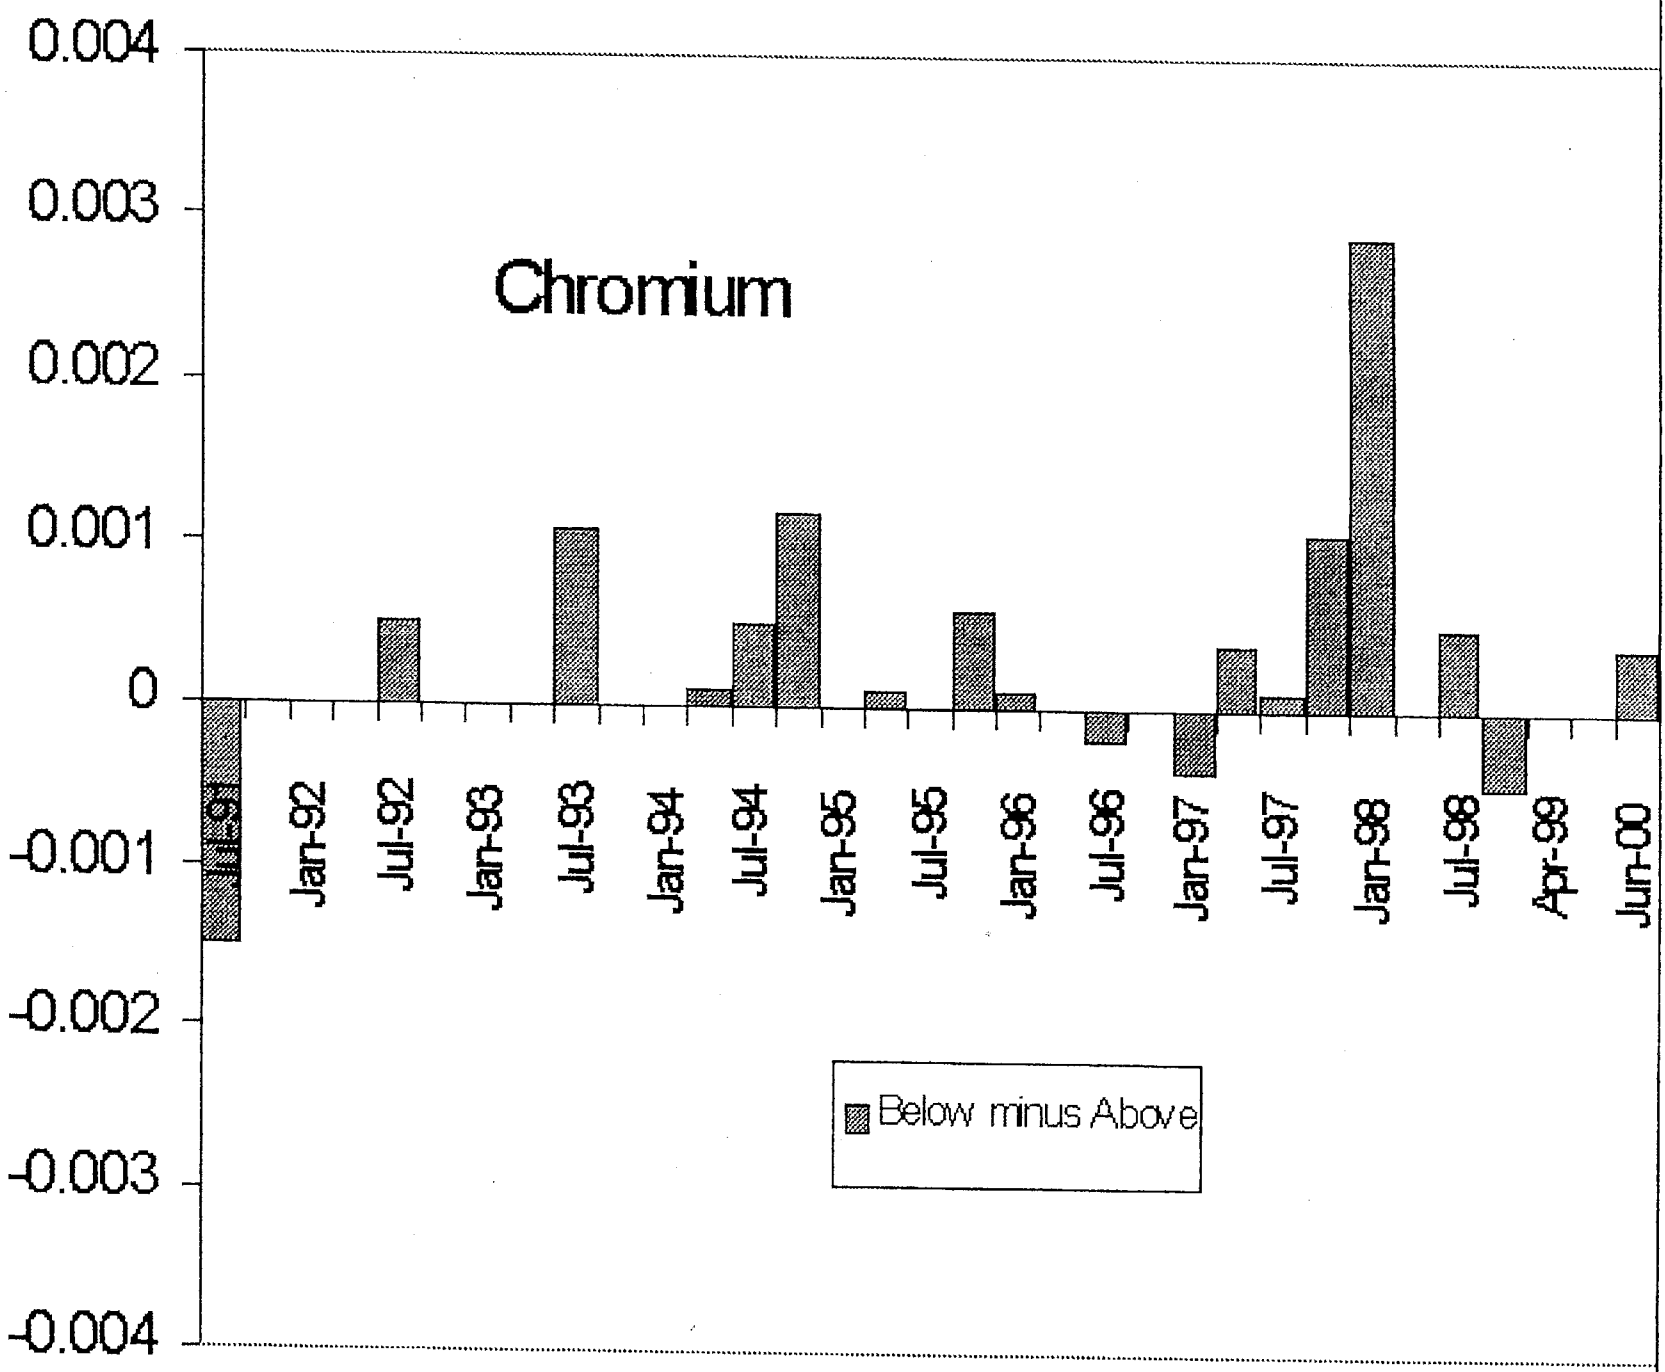
Fig. 2

to 2000 for these parameters, 102 parameters are higher below the mine and 47 are lower below the mine. This overall trend in the parameter values is highly significant (Sign test, $P < 0.001$; Zar 1984) and suggests that examination of the individual parameters is warranted. The baseline data collected prior to October 1992 shows parameter values to be similar above and below the mine site but is statistically inconclusive. The 1990 FEIS for the project stated there was no difference in water quality above and below the mine site based on 1987 and 1988 water testing. When examining the data collected after the start of significant activity at the mine site (data since October 1992) for individual parameters, one finds that all the parameters show a tendency to have higher values below the mine than above the mine. Most of these tendencies are statistically significant when the paired samples are tested for significance with the Wilcoxon Signed Rank test (Zar 1984). For example, chromium (Fig. 2) showed a statistically significant tendency to be higher below the mine since October 1992.

Chromium.- The pairs of samples collected above and below the mine from Oct. 1992 to 2000 show significantly higher values for chromium below the mine than above (Wilcoxon Signed Rank test, $P=0.005$).

Difference Between Below-Mine Sample
and Above-Mine Sample (ppm)

Chromium
