Reclaimed Flambeau Mine

While there are other examples of successfully operated and reclaimed metallic mines in Wisconsin, the Flambeau Mine near Ladysmith in Rusk County is the only example of a metallic mine that was permitted, constructed, operated and reclaimed under the state's existing regulatory framework.

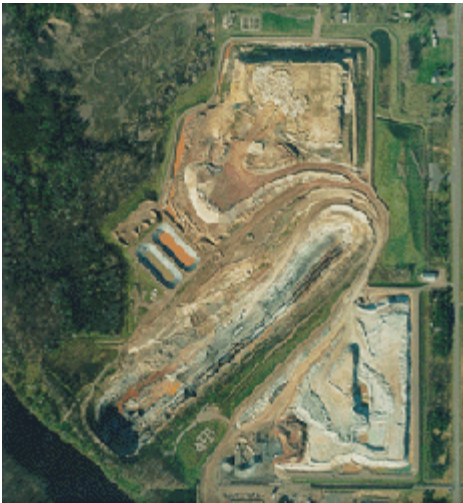
An aerial view of the Flambeau Mine during active mining operations. The Flambeau River is located at the southwest corner of the photograph.

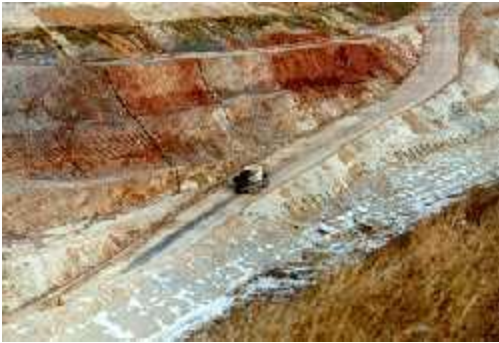
Haul trucks removed ore from the Flambeau Mine.

Material was hauled out of the pit using 55-ton trucks and deposited in appropriate stockpiles. Once bedrock was reached, operators drilled and blasted the ore and waste rock prior to hauling. Ore was crushed on-site and shipped by rail to facilities in Canada for concentrating and smelting. The open pit mine operated two ten-hour shifts per day, five days per week. Material was removed at a rate of about 6,500 tons per day.

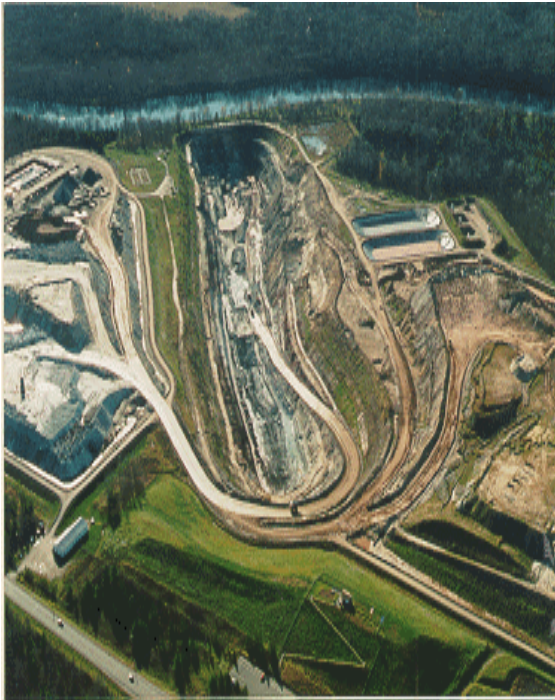
View, looking southwest, of the Flambeau Mine during operations.

Mining of this shallow ore body was accomplished through a 35-acre open pit. The pit faced in a northeast-southwest direction and was 2,600 feet long, about 550 feet in width, and reached an ultimate depth of about 220 feet.

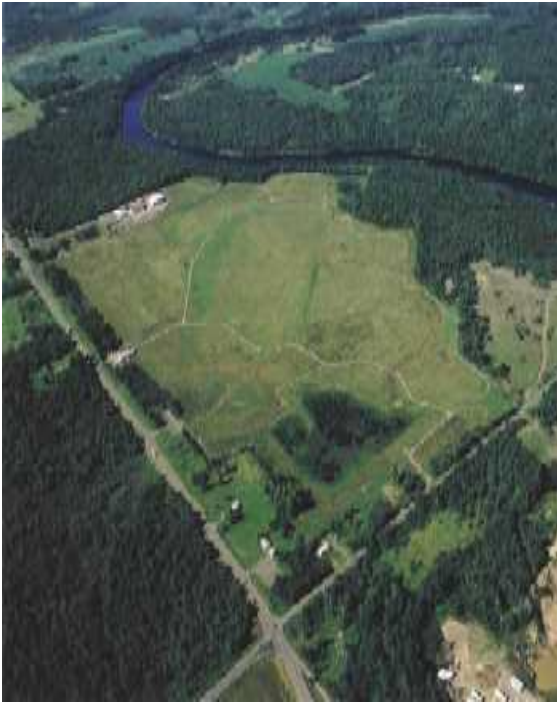
View, looking southwest, of the reclaimed Flambeau Mine.

Once the crushed limestone was added, the material was hauled to the pit and backfill then placed in the pit and compacted. The high-sulfur waste rock was overlain by low-sulfur waste rock, weathered bedrock, sandstone and glacial till. The site was graded to the approximate pre-mining condition and provide for adequate surface drainage. Topsoil was reapplied to the site and revegetation and wetland restoration efforts began.

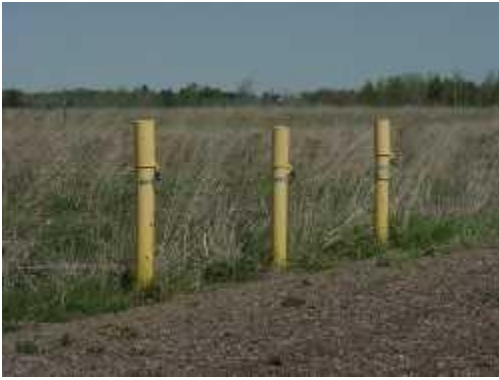
Groundwater monitoring wells at the Flambeau mine. Water quality within the backfilled pit will continue to be monitored in order to assess potential impacts to the Flambeau River.

The first few rounds of well samples collected in 1999 indicated that elevated levels of sulfate, copper, manganese and iron were present. These results were not a surprise and were approximately equal to or slightly greater than the concentrations originally predicted. Long-term trend analysis of data collected from 1999 to 2012 on in-pit wells suggested two wells had increasing trends in copper (MW-1013B) and iron (MW-1013C), but stable or decreasing trends dominated elsewhere within the pit wells. It is difficult to make any long-term predictions of how the site will perform, but analyses to date indicates there is no acid production in the pit (porewater is saturated with respect to calcite and gypsum), groundwater elevations have generally stabilized since recovering in 2003, and metals concentrations in the in-pit water are not at levels that pose a threat to water quality in the Flambeau River.;

In addition to the wells located within the backfilled pit, groundwater samples are collected quarterly at wells surrounding the backfilled pit. Some of these wells recorded sharp increases in concentrations of copper, sulfate and/or manganese since mine pumping stopped in 1997. However, recent data suggest levels for these parameters have steadily decreased since the wells have fully recovered. Wells MW-1000R and MW-1004 have only recently recovered (2010) enough to allow for recovery of groundwater samples due to persistent drought conditions since the mine's closure.
